COMPETITIVE ENGINEERING DEPARTMENT

RXL BULLETIN NO. 1 (1977/78)

INFORMATION AND CHANGES RESULTING FROM ALASKA TEST TRIP AND RXL SEMINARS:

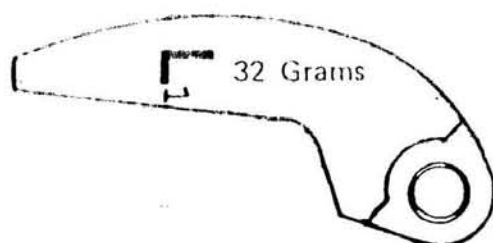
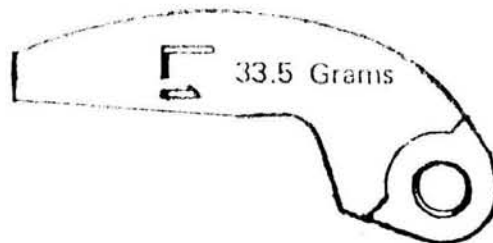
Weight Identification -- See Figure:

PROBLEM:

Low Engine RPM

High Engine RPM

Try next heavier blue clutch spring, part no. 7041080. If engine RPM needs to be raised more, install lighter clutch wts. 32 grams, part no. 5630188.

Try lighter orange clutch spring, part no. 7041060. If engine RPM needs to be lowered more, install next heavier clutch weight.

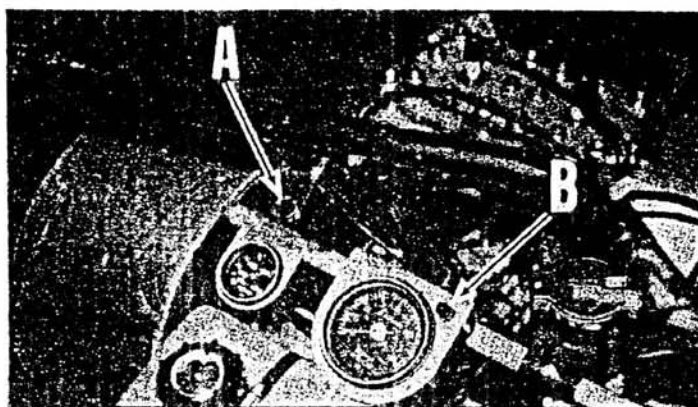
TETHER SWITCH RELOCATION:

Refer to the photo below showing the relocation of the tether switch from the handlebar location (A) to the tachometer location (B). Measure 1/2" down from the inside radius of the tachometer mount and 1/2" in from the right side; see photo. At this point drill a 1/2" hole for the new tether location.

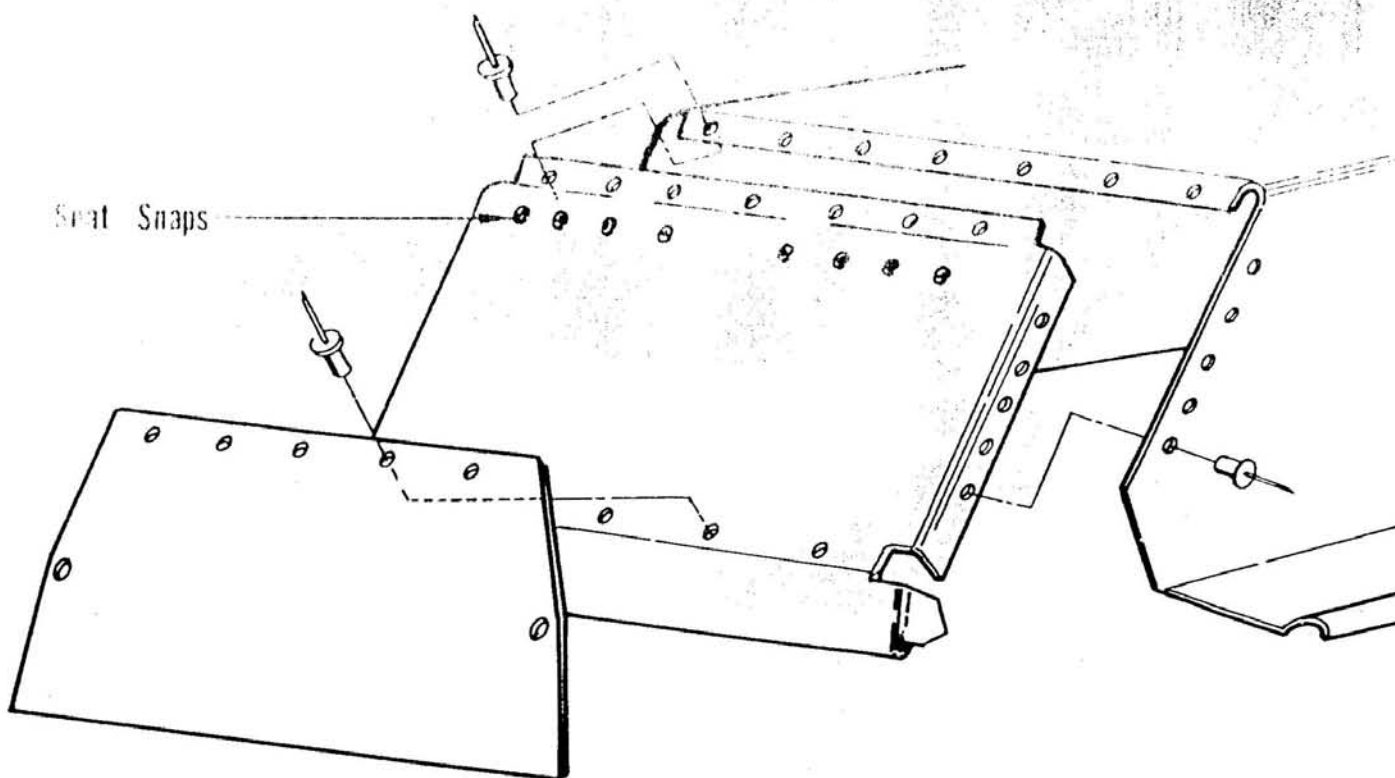
REAR CLOSE-OFF PANEL (INCLUDED IN RXL ENGINE KIT)

SUBJECT: MANDATORY USSA RULES

Procedure: Remove present close-off panel and snow flap by drilling out existing pop rivets. Install the replacement close-off panel using the top tunnel rivet holes as a line-up reference (see illustration). Secure with rivets on the top of the tunnel first. Next, drill the side panels with 5/32" drill size. Secure with 5/32 x 1/2" rivets. Fasten the snow flap to the close-off panel using 3/16 x 1/2" rivets. Relocate seat snaps and secure with rivets.
